Manhole Inspection Summary

Manhole # S11O__006MH

Location Address: **405 S. Caton**

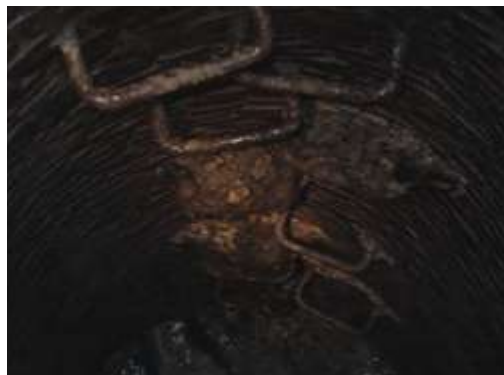
Defect 4

Infiltration: ☐ None ☐ Joint ☐ Cracks ☐ Mortar ☐ Roots ☒ **Wall**

Barrel infiltration, build up on steps

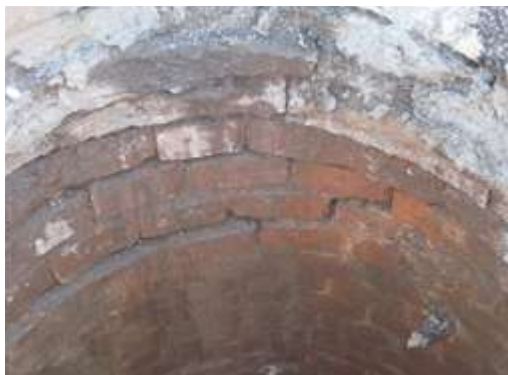
Defect 3

Condition: ☐ Sound ☒ **Cracked** ☐ Root Intrusion ☒ **Loose Brick** ☒ **Deteriorated**

Infiltration: ☐ None ☐ Joint ☐ Cracks ☐ Mortar ☐ Roots ☒ **Wall**

loose bricks and mortar under frame/
evidence of infiltration at the chimney and
corbel

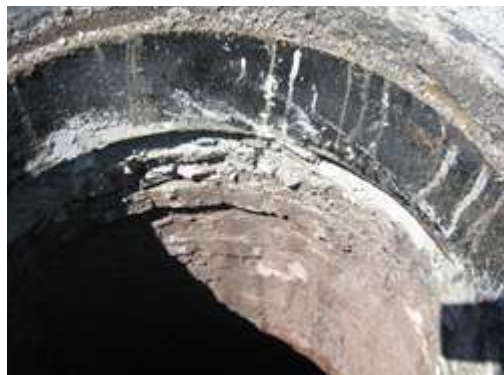
Defect 2

loose bricks and mortar under frame

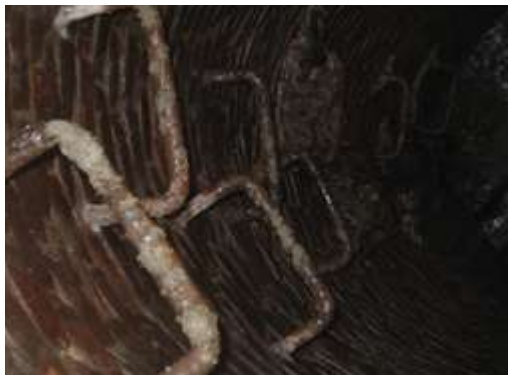
Defect 1

Count: **13** Missing: **2** ☒ **Corroded**

corroded steps

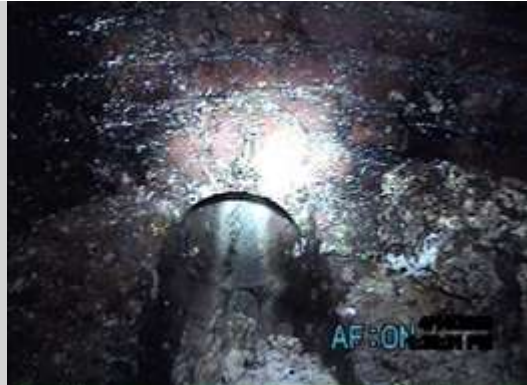
12 O'Clock Outflow

evidence of Barrel infiltration
